EIFS Moisture Intrusion Inspection Report

October 6th 2004

XXXX XXX XXXXXX, Allen, TX

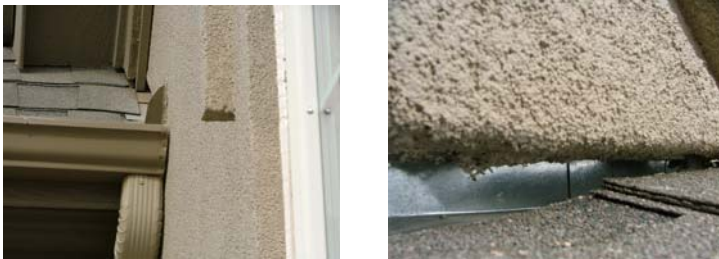
5.3. 6-9. Roof & Gutter Details:

In this application, it appears that the details are properly installed although we cannot verify backwrapping.

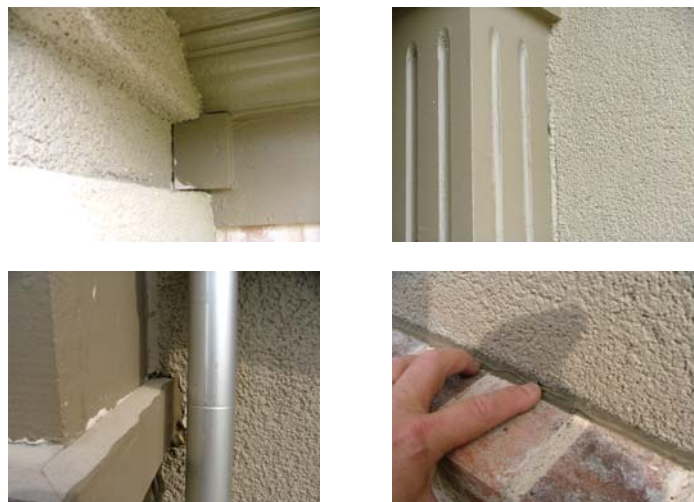
5.4. 10. Dissimilar Materials:

Expansion type joints are required where EIFS meets dissimilar materials, or where the substrate materials change (i.e. where the wood framing sits on the masonry foundation wall). On this house, there is no expansion joint detail at the foundation level or at transitions between the brick veneer and the EIFS, and between wood trim and the EIFS.

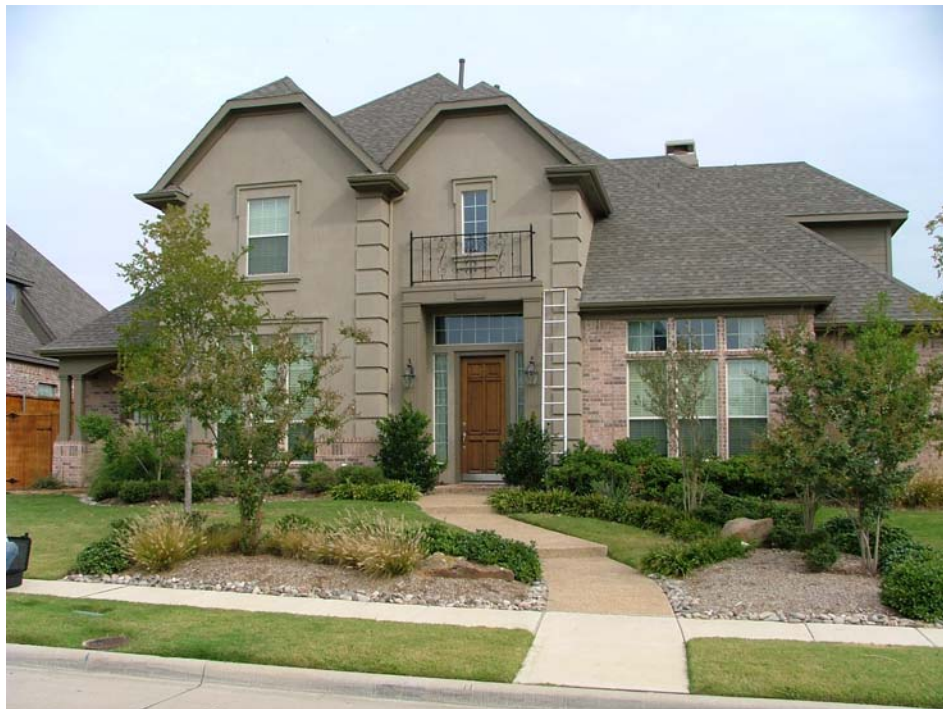
5.7. 13. Control Joints:

Expansion joints at each floor level are a requirement for most manufacturers and the EIMA. Without the expansion joints, as the house shrinks and settles, it could detach and crack the EIFS over time, leading to moisture intrusion. These control joints should be installed at the first floor/foundation line, and at the attic level. These control joints are less important when the EIFS is installed during a rehab of an existing house. We observed no significant cracking or detachment caused by the lack of control joints.

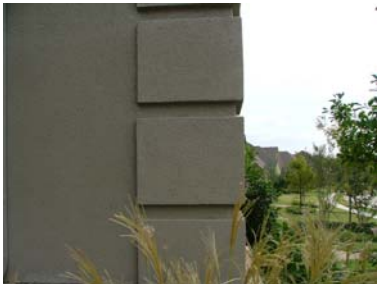
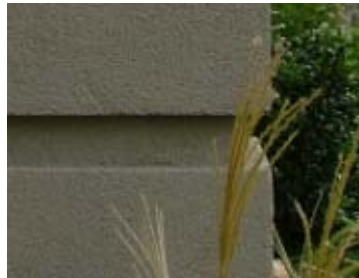
5.9. 16. Architectural Accents:

The architectural accents should have required beveled tops, which allow moisture to run off rather than stand on the EIFS facing.

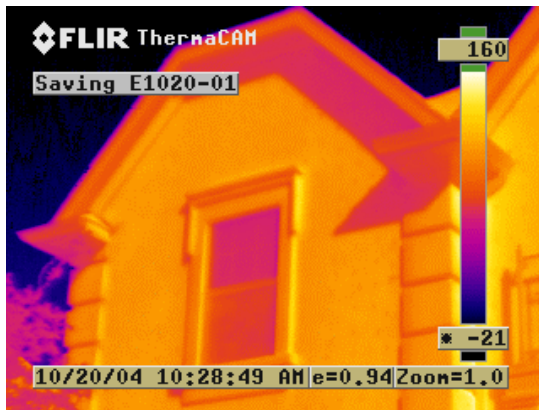
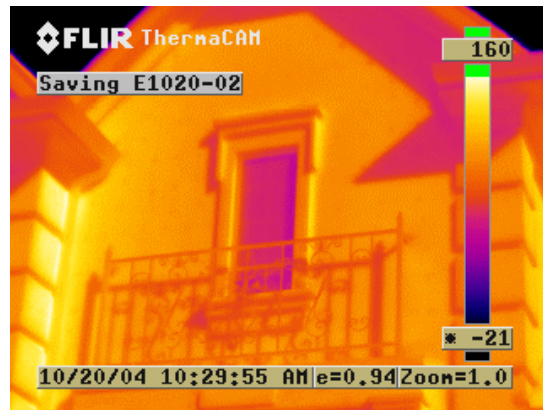
Front view of the upper areas of the home. Note no thermal difference.

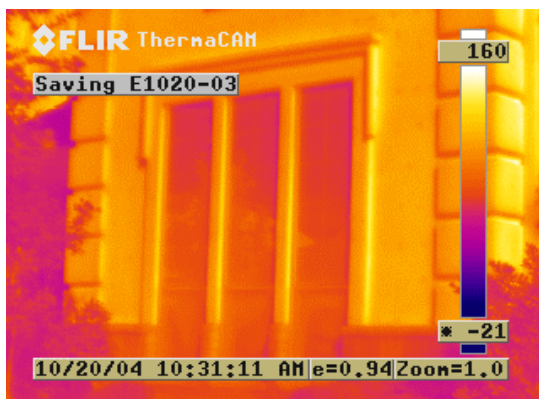
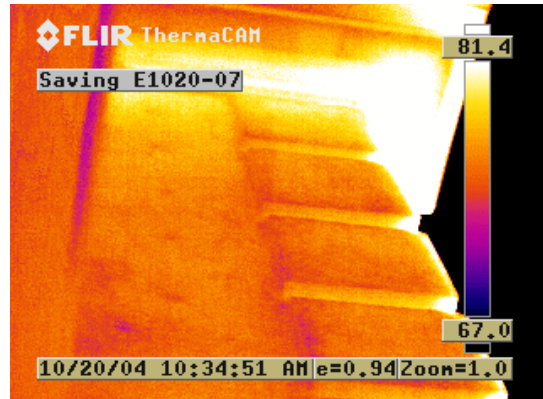
Font view of the window and architectural front entry. No thermal difference.

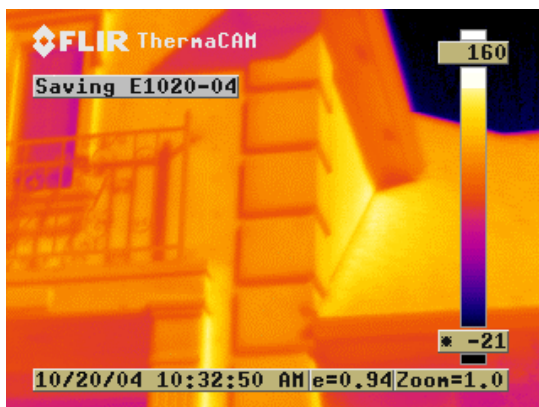
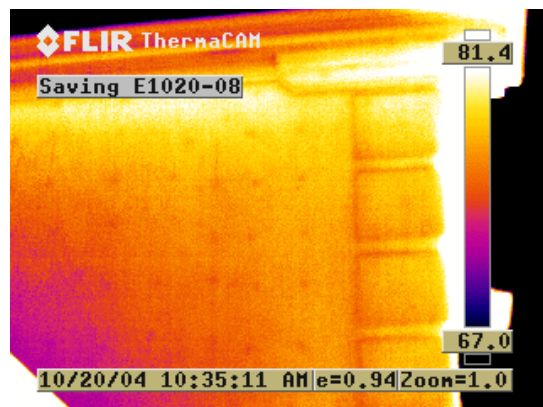
Font view of the upper architectural front entry. No thermal difference.

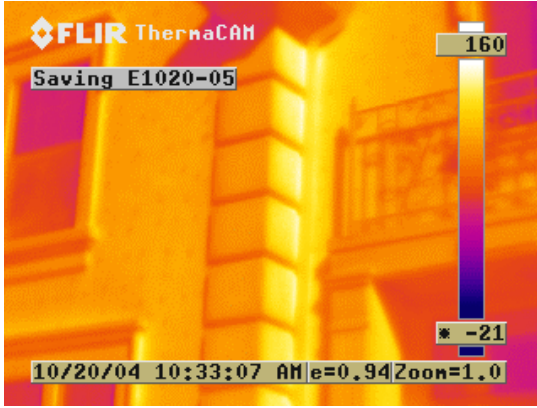
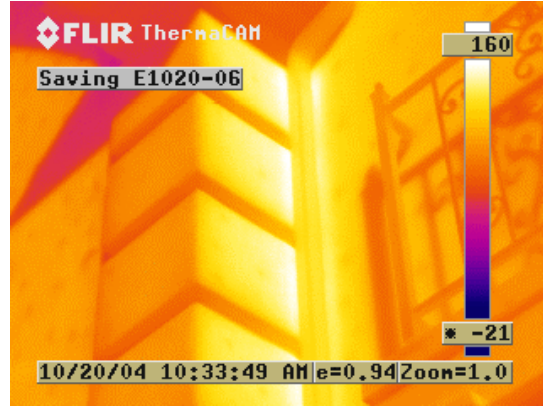
Front view of the window and architectural front entry. No thermal difference.
